Report of the  
**PRESIDENTIAL  
COMMISSION**

*on the Space Shuttle  
Challenger Accident*

June 6th, 1986  
Washington, D.C.

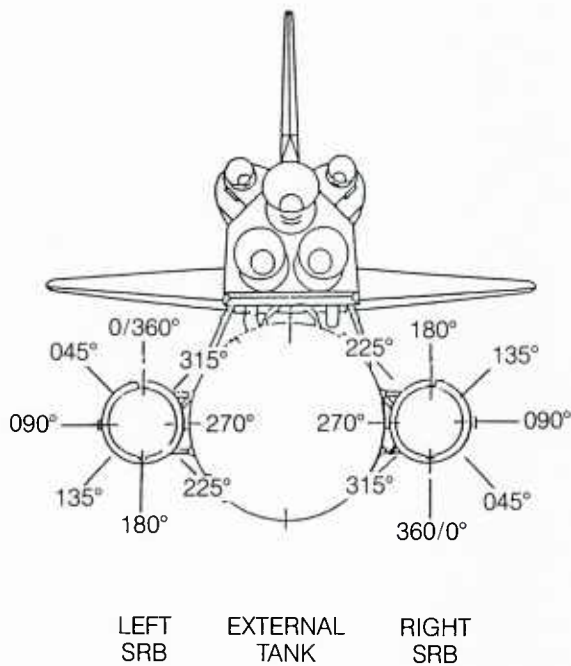
**Angular Coordinate System  
For Solid Rocket Boosters/Motors**  
Figure 26

parts 131, the upper segment tang region, and part 712, the lower clevis region of the joint. This burned area extends roughly from station 1476, in the upper section, to 1517 on the lower region. In a circumferential direction (see figure 26) the lower end of the eroded region extends from roughly 291 degrees to 320 degrees and the upper eroded section extends between 296 and 318 degrees. Note that the region at about 314 degrees includes the attachment region of the strut to the attachment ring on the right Solid Rocket Booster.

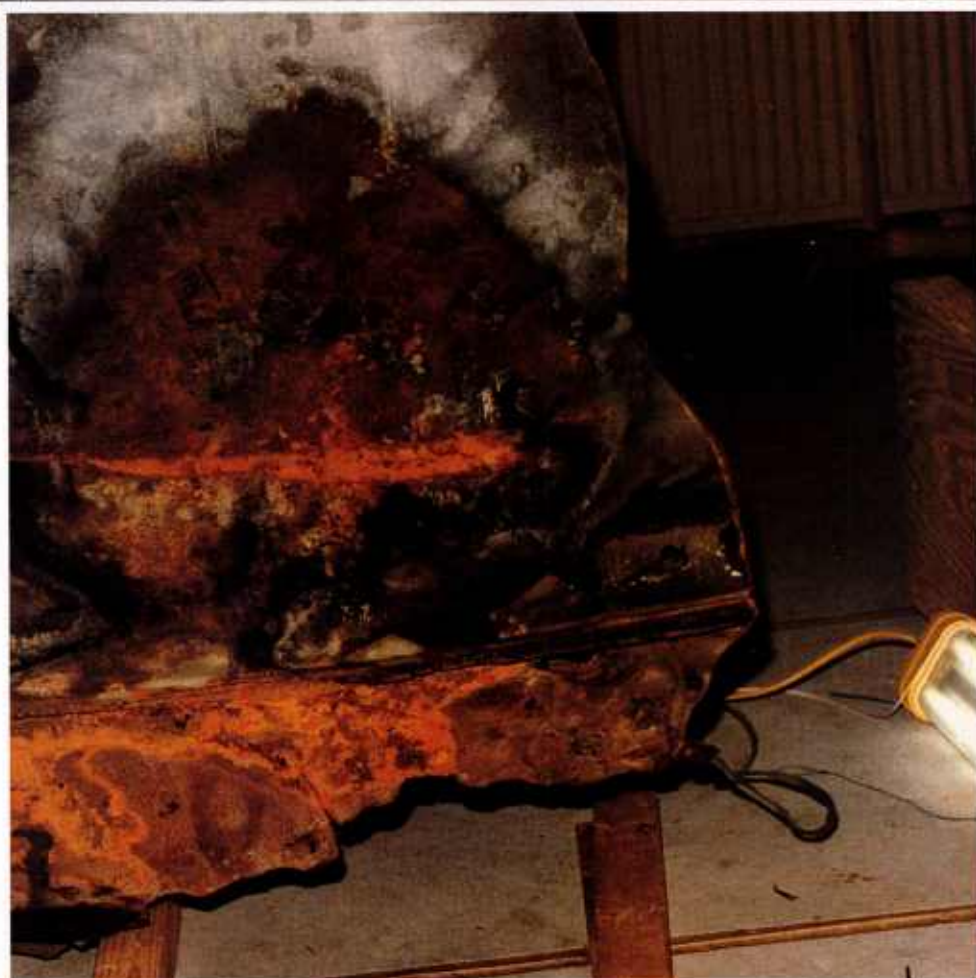
M

Examined at Kennedy Space Center after their recovery from the ocean, these fragments show the extent of burn through the right hand booster's aft field joint. On the left page are sections of the aft center motor segment above the joint. On the right page are sections (inverted) of the aft motor segment showing burn-hole below the joint (bracket). Except for the interior views on lower left, the camera is viewing the parts from outside the casing.

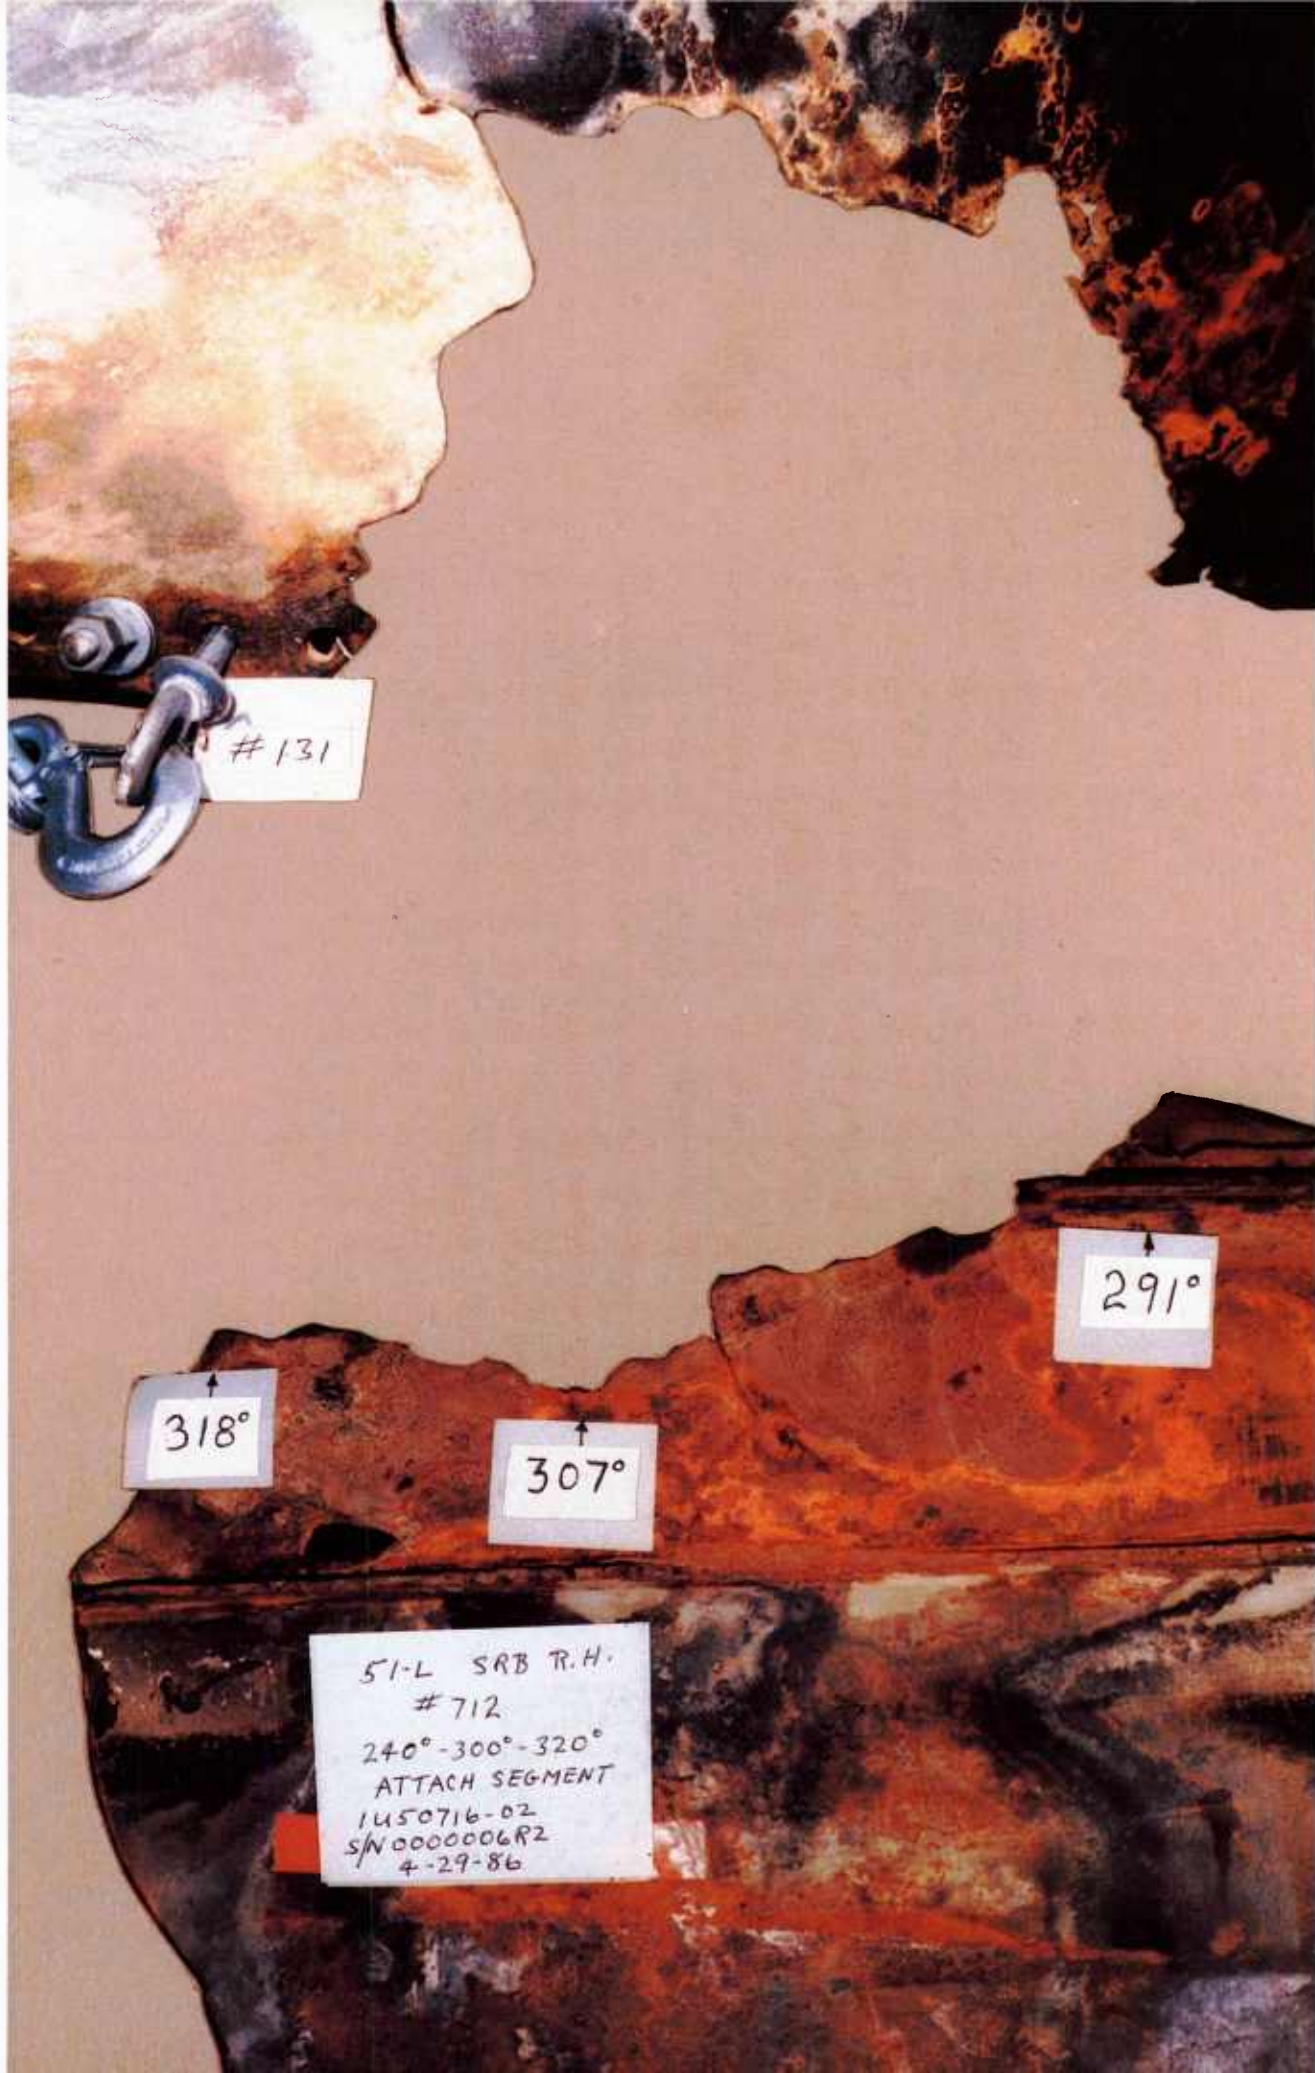
#131

Some observations were made from a detailed examination of the aft center section of the joint, contact 131. This piece (photo I) shows a large hole that is approximately centered on the

307-degree circumferential position. Although irregular, the hole is roughly rectangular in shape, extending approximately 27 inches circumferentially along the tang (296 to 318 degrees) with total burnout extension approximately 15 inches forward of the tang. At either side in the interior of the hole (photo K) the insulation and steel case material showed evidence of hot gas erosion that beveled these surfaces (indicative of combustion products flowing through the hole from the interior of the Solid Rocket Motor). The top surface of the hole was hardly beveled at all. The

At upper left is the aft segment burn viewed from inside the casing; the lower photo is a closeup of the same section. The latter photo shows a hole (arrow) where the flame plume may have burned through the casing from the outside. At right is a composite view of the burn above and below the aft field joint.

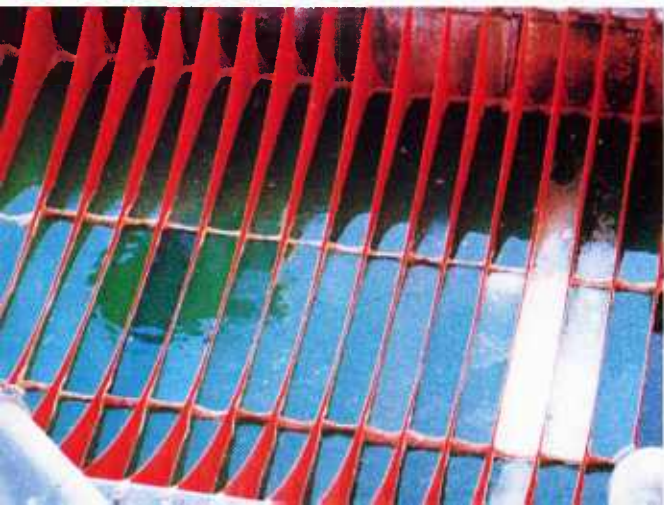
Above, Shuttle 51-L on Kennedy Space Center Pad 39B in the early morning of launch day. Temperatures were well below freezing, as indicated by the lower left photo, which shows thick ice in a water trough despite use of an anti-freeze solution.

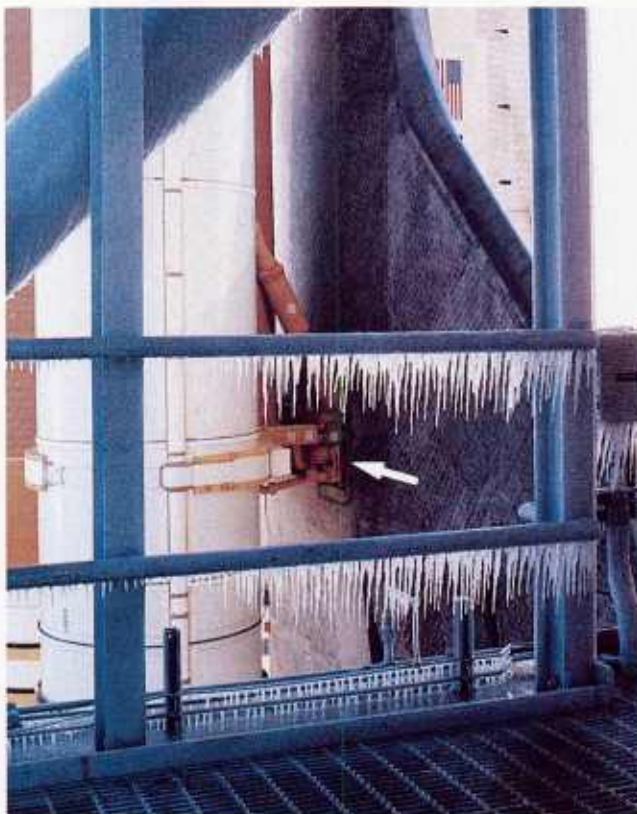
Above, foot long icicles on a lower level of the Fixed Service Structure frame the attachment point where the Orbiter is attached to the external tank (arrow). Icing was even more extensive at upper levels of the service structure (upper right and below). At right below is a ground communications box (not used during launch) rendered inoperable by heavy ice.

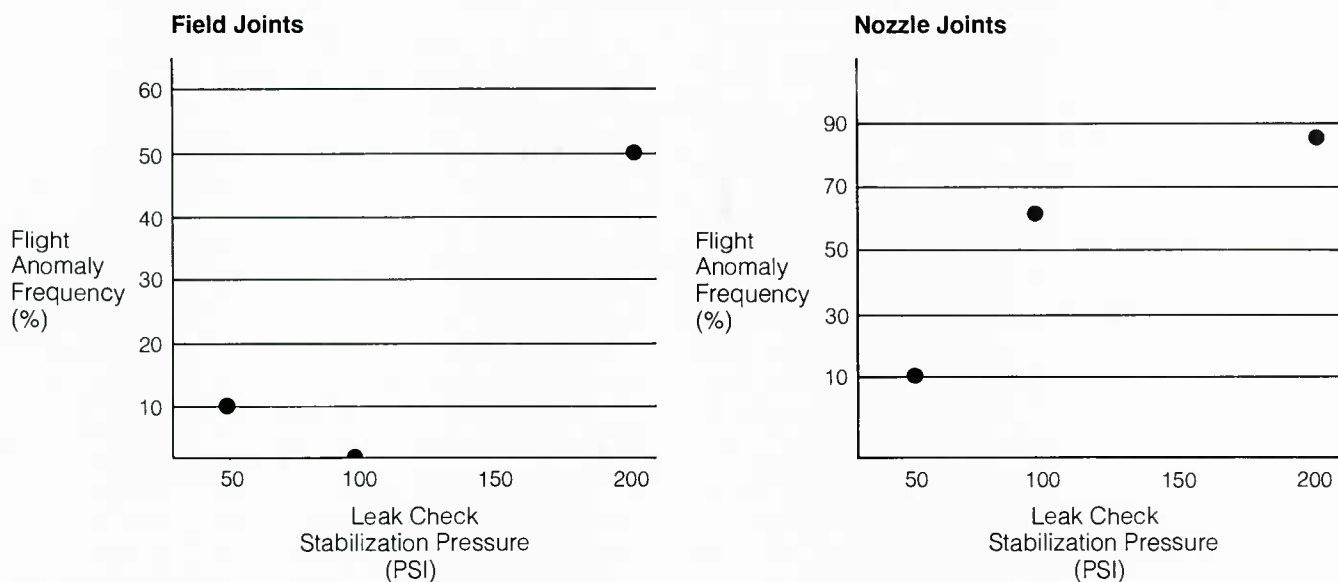
Graphs depict flight anomaly frequency for both field and nozzle joint of solid motors for a variety of leak check pressures. Figure 3

This hypothesis that O-ring erosion is related to putty blow holes is substantiated by the leak check history (Figure 3). Prior to January, 1984, and STS 41-B, when the leak check pressure was

The trends of flight anomalies in relation to leak check stabilization pressure are illustrated for the field joint and the nozzle joint in Figure 3, on page 133. While the data point concerning the 100 pound per square inch field joint leak check is not conclusive since it is based on only two flights, the trend is apparent.

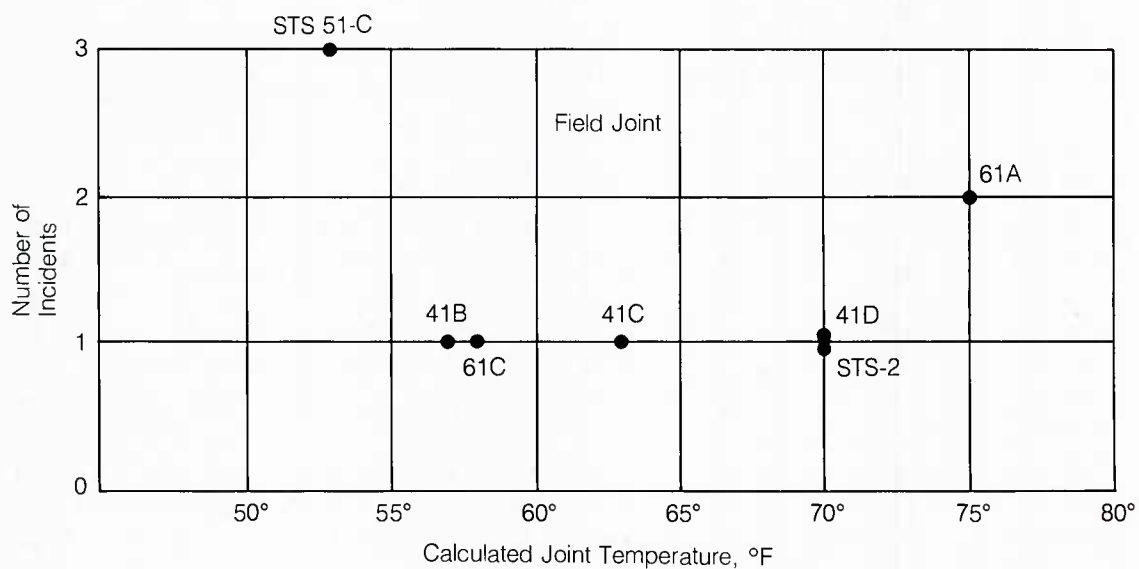
cy of occurrence based on all flights (Figure 6 ). In such a comparison, there is nothing irregular in the distribution of O-ring "distress" over the spectrum of joint temperatures at launch between 53 degrees Fahrenheit and 75 degrees Fahrenheit. When the entire history of flight experience is considered, including "normal" flights with no erosion or blow-by, the comparison is substantially different (Figure 7).

Figure 6  
Plot of flights with incidents of O-ring thermal distress as function of temperature

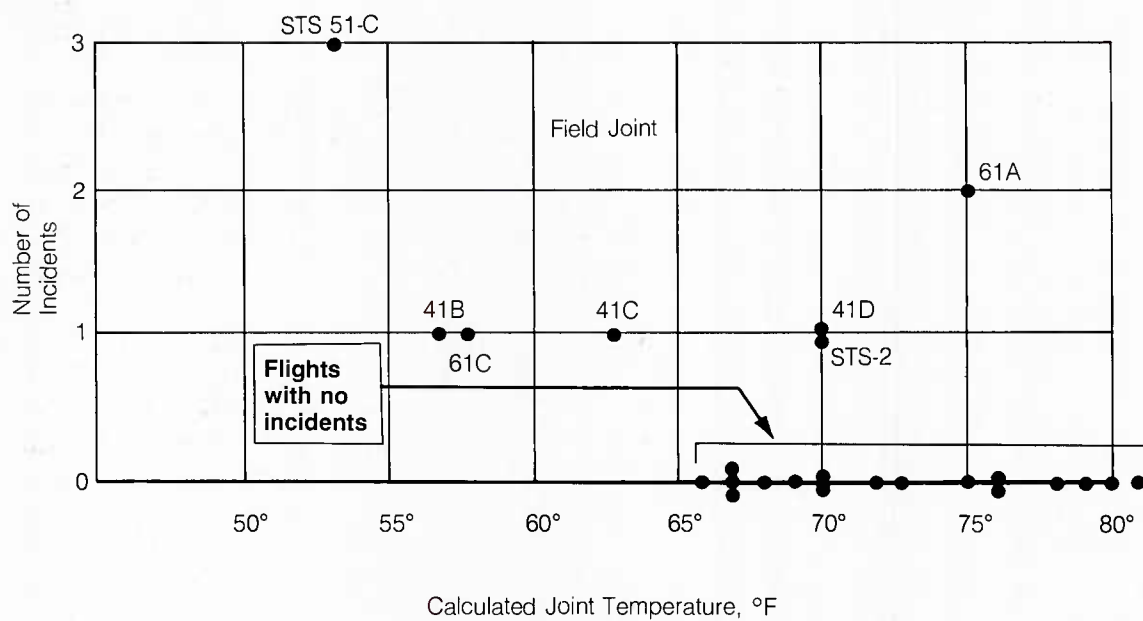
Figure 7  
Plot of flights with and without incidents of O-ring thermal distress

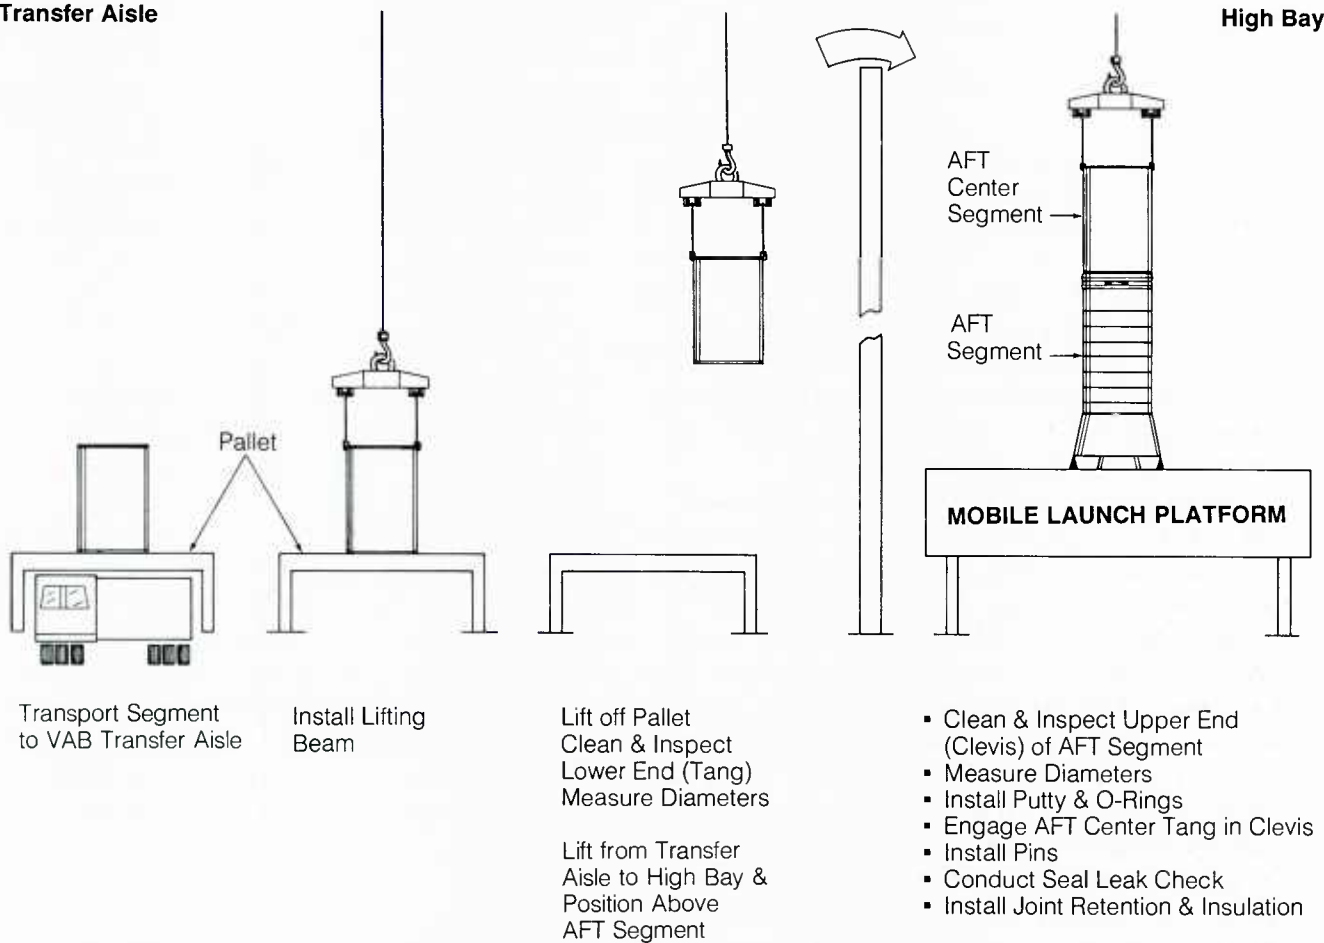
Drawing depicts steps in the stacking of the aft and aft center segments of the Solid Rocket Booster in the Vehicle Assembly Building (VAB).

stacking interference. Taken across the 0-180 degree axis, the tang diameter measurement exceeded the corresponding clevis dimension by +.512 inch. The maximum allowable tang to clevis difference is +.250 inch.
